Volvo V50

Clutch Replacement

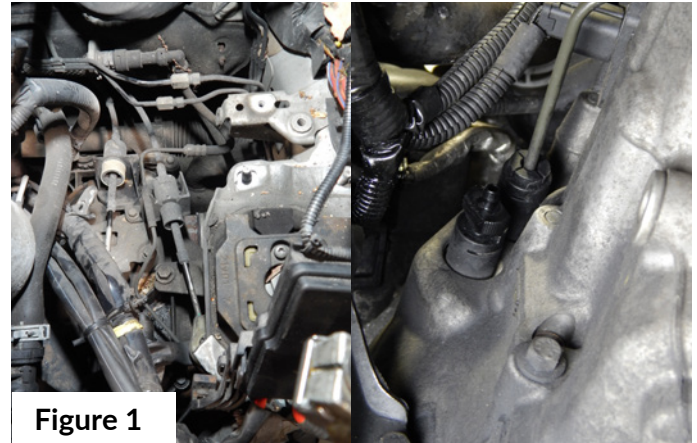
Figure 1

With the top of the transmission visible, the two gear selector cables were unclipped from their mounting points and secured out of the way. The reverse lamp switch and the neutral switch wiring harness connectors were unclipped, along with the CSC hydraulic pipe connection. The open end of the connector was sealed with a plastic cap to stop any excess fluid from leaking out. (Fig 1)

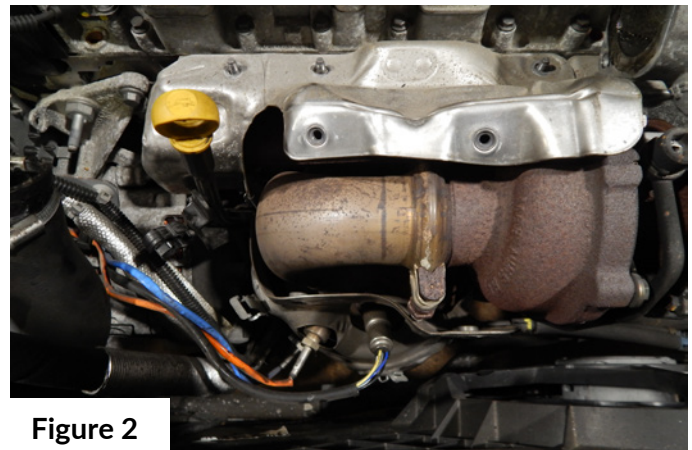
Figure 2

The diesel particulate filter (DPF) fitted to this engine needs to be lowered in order to gain access to one of the front bell housing bolts. The temperature and lambda sensor wiring harnesses were disconnected along with the differential pressure sensor pipes. The air intake pipe, heat shield and retaining clamp were removed, and then the DPF was able to be eased down to give clearance for the removal of the bell-housing bolt. (Fig 2)

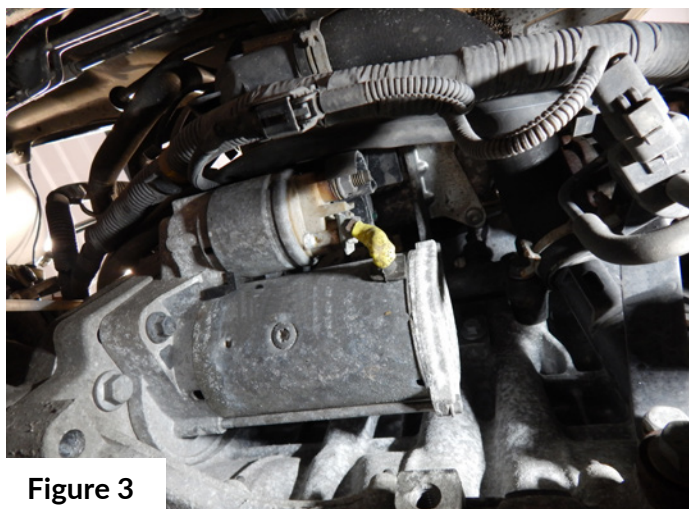
Figure 3

Working from under the vehicle, the last starter motor bolt was located and taken out. The starter motor was supported and left in place because it does not need to be removed completely for the removal of this transmission. (Fig 3)

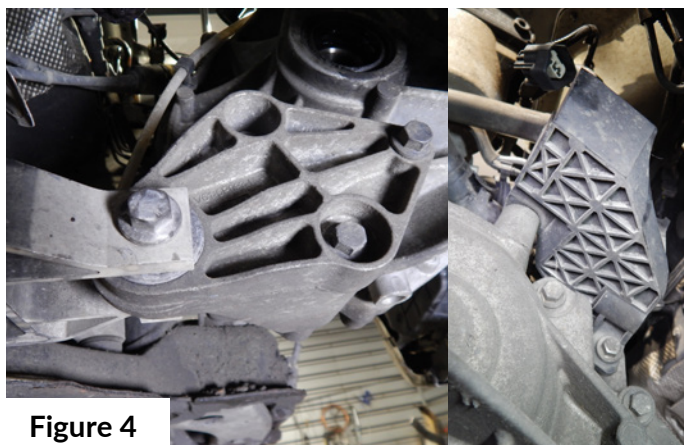
Figure 4

Next was the removal of the gearbox torque mounting - followed by the gear selector cable bracket to give extra clearance when removing the transmission. (Fig 4)

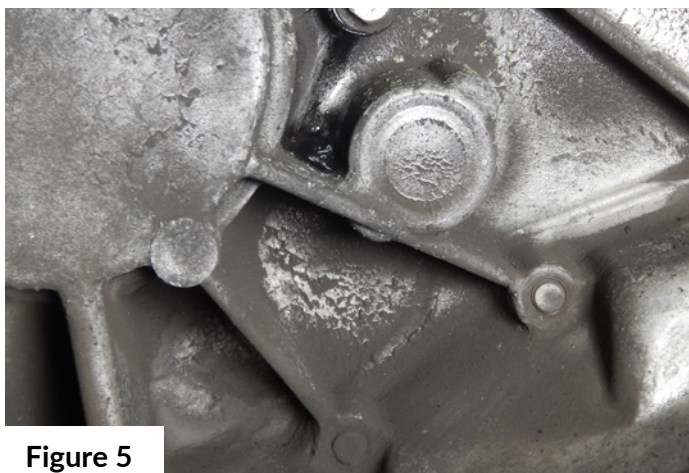
Figure 5

The engine was supported, the top transmission mount was released and the last of the bell housing bolts were removed, before separating the transmission from the engine. The transmission was lowered to the floor and inspected. Upon inspection of the bell housing it became obvious that the CSC had been leaking - causing the loss of fluid in the clutch system and the poor pedal performance. (Fig. 5)

The leaking CSC was removed. The bell housing and the input shaft were thoroughly cleaned of all grease, dirt and old friction fibres from the previous clutch and the input shaft seal was inspected before fitting the new CSC (ADM53635).

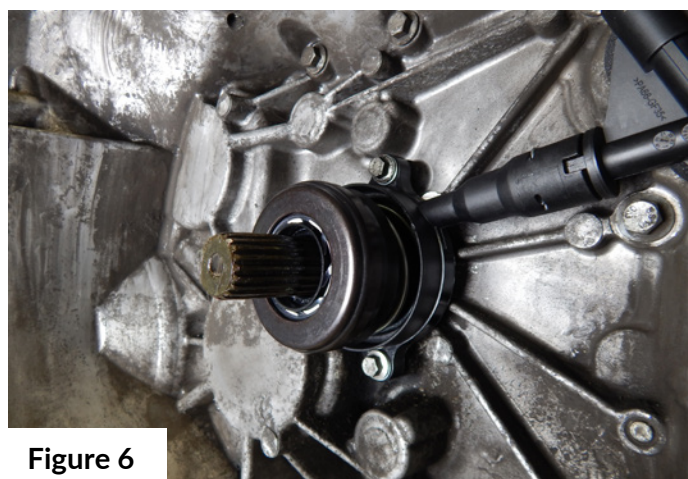
Figure 6

The transmission input shaft splines were lightly greased in preparation for installation. (Fig 6)
