Daihatsu Sirion Clutch Replacement

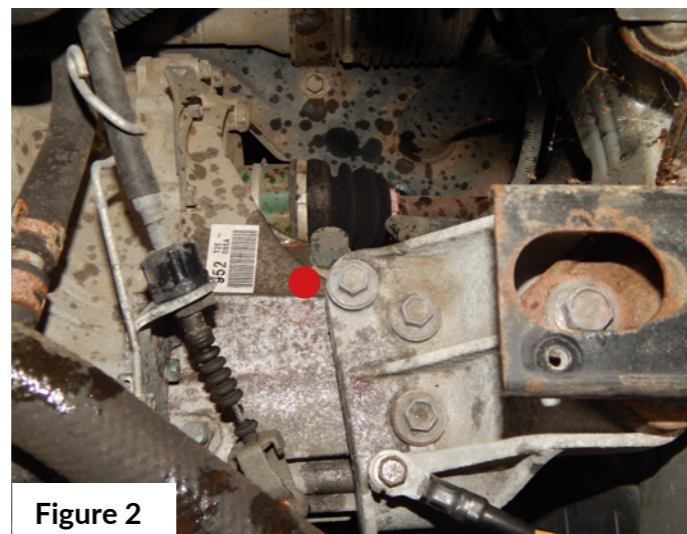
Figure 2

First, the battery and battery tray were removed; this was to give access to the clutch cable, which was slackened and retained out of the way, along with the cable-retaining clip.

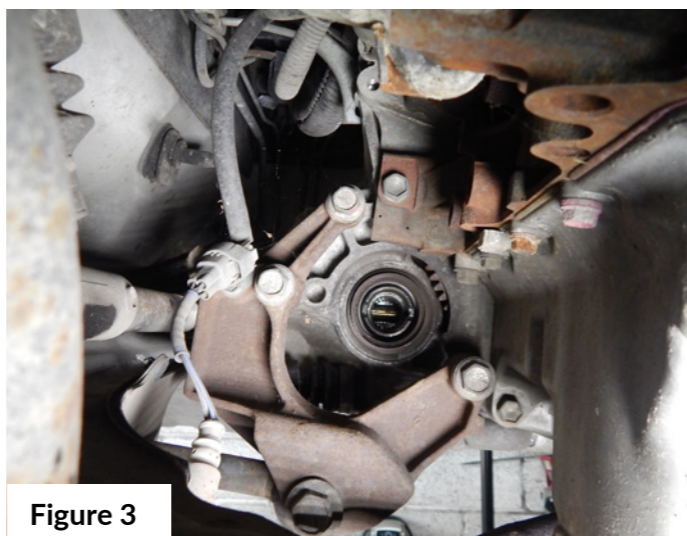
Figure 3

This was followed by the removal of the transmission oil drain plug, which is located below the left driveshaft. Once the oil was drained, both the driveshafts were removed from the hubs and a suitable lever bar was used to release the inner driveshaft joints from the differential.

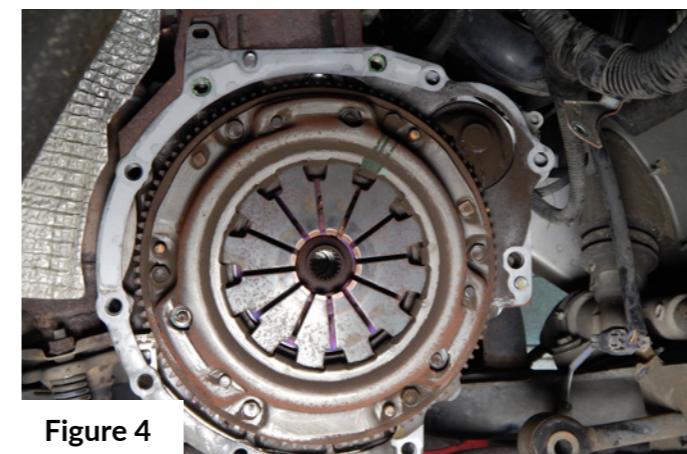
Figure 4

Moving to the left of the car, the plastic transmission shield was taken off to reveal the reverse lamp switch wiring harness, which was unclipped. All that was left to be done before the transmission could be removed was to support the engine and take off the two transmission support mounting brackets. It is important to be careful not to damage the lambda sensor while removing the right hand mounting bracket. The last of the lower bell housing bolts was removed, and then the transmission was separated from the engine and lowered from the vehicle.

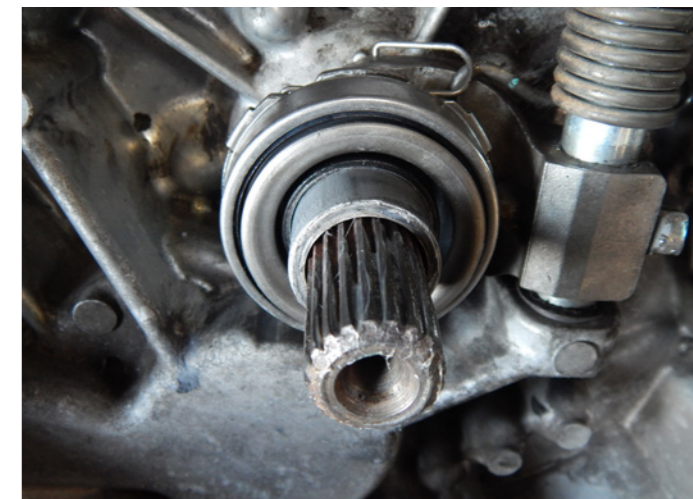
We then turned our attention to the release mechanism; the bell housing was thoroughly cleaned to free all grease, dirt, and old friction fibres from the previous clutch. The release bearing was removed from the clutch fork; the bearing had become dry and noisy with use and age.

The image shows the release bearing fitted with the clip locked correctly in place on the release fork. There is also a lower retaining clip not shown in this image.

Before fitting the new release bearing, the fork and release lever were inspected for any fractures or damage. The contact points of the new bearing were lubricated and the retaining clips in the grooves of the fork were correctly located before the fork was fixed in place with the retaining bolt. It is important to correctly locate the retaining clips on the fork and the orientation of the release bearing – failure to do so can create operational issues with the clutch mechanism.
