Loss of communication

The featured vehicle is the popular Škoda Yeti. The owner reported having issues with the right-hand rear door not locking and the electric window not working.

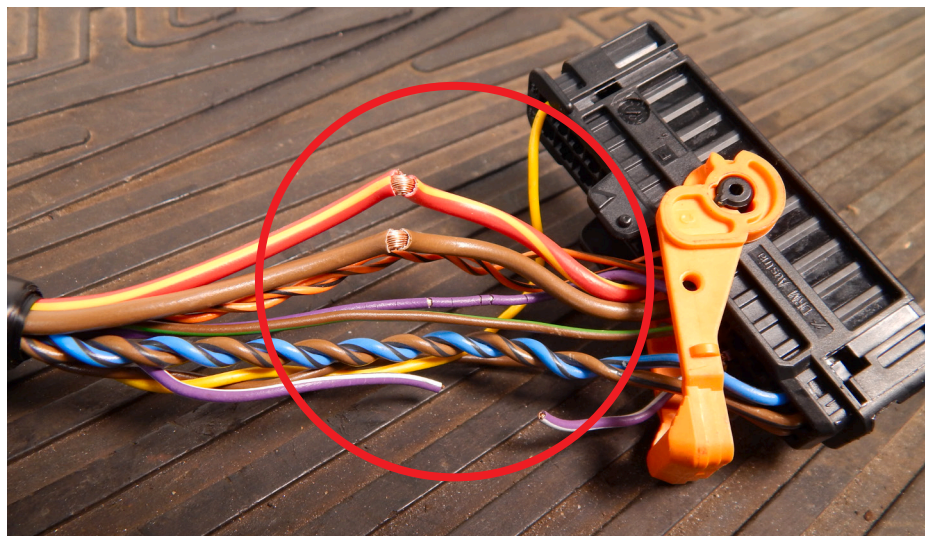
Figure 1

After removing the right-hand front door trim panel and checking the wiring, the fault was found to be a broken wire between the 'A' pillar and the door.

All wiring looms that connect between the vehicle's body to the doors – or any other hinged point – are subject to a lot of movement, bending, and stretching to the point where the insulation cracks, therefore exposing the copper wire. This can lead to an open or a short circuit in the system. (Fig 1)

With the fault identified, the option was to either repair or replace the wiring loom. A febi wiring repair kit was chosen, which
