1.2 PureTech

Wet Timing Belt Replacement

The vehicle featured in this article is a 2013 Peugeot 208, fitted with the naturally-aspirated version of this engine. It was due its first timing belt replacement at 112,500 miles (180,000 km) and there were no other issues reported by the owner.

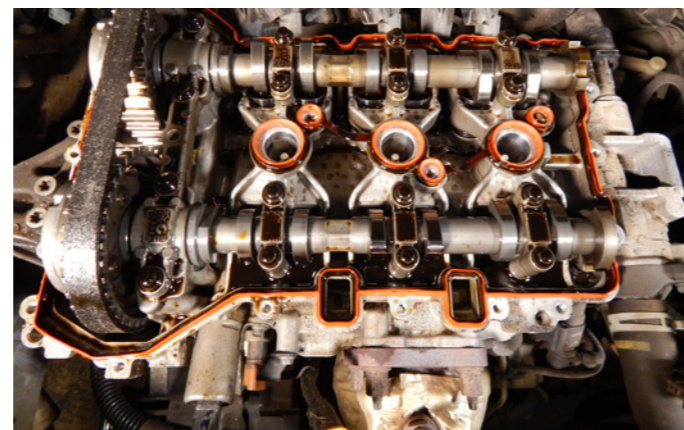
Figure 1

Lowering the vehicle, working from the top of the engine, the air filter housing was removed (taking note of the position of any of the pipes and wiring connectors) for reassembly. The three ignition coils were removed and several hidden pipes were unclipped before unbolting the inlet manifold. Once the inlet manifold was free from the cylinder head, this was then moved out of the way to expose the rocker cover. All of the bolts were removed, followed by the removal of the rocker cover - revealing the camshafts and the timing belt. (Fig.1)

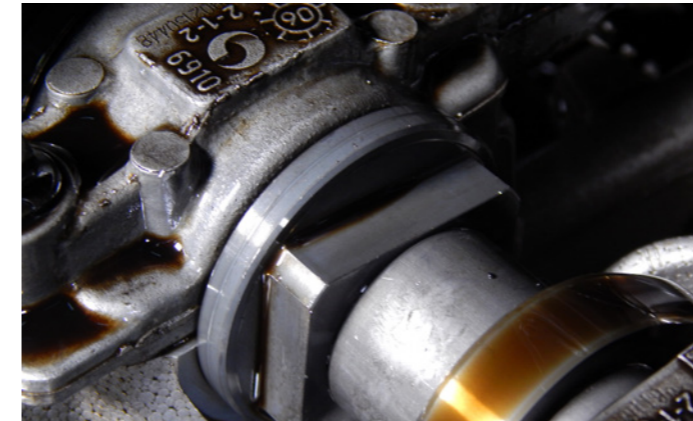
Figure 2

Next, the engine was turned over clockwise at least two times using the crankshaft bolt, until the upper flat surface of the camshafts was inclined by around 30°. This brought the alignment of both the camshafts and the crankshaft ready for the engine locking tools to be installed. (Fig.2)

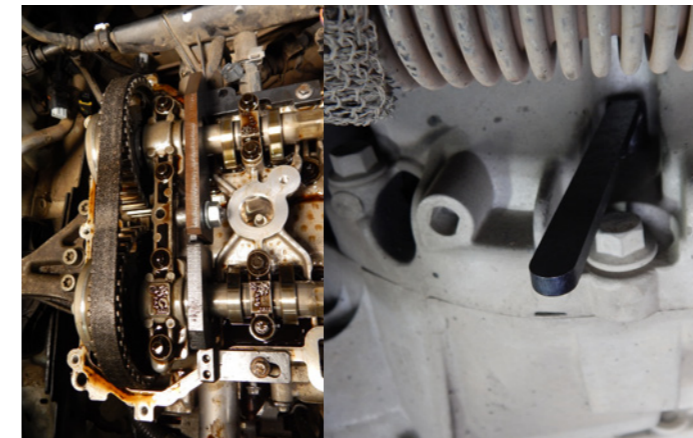
Figure 3

The engine was slowly turned clockwise by means of the crankshaft pulley bolt and the flywheel-locking tool was inserted. The connector of the injector closest to the camshaft pulley was disconnected and the camshaft-locking tool was installed. These were adjusted to fit the camshafts, fixing them to the cylinder head with the retaining bolts. (Fig.3)

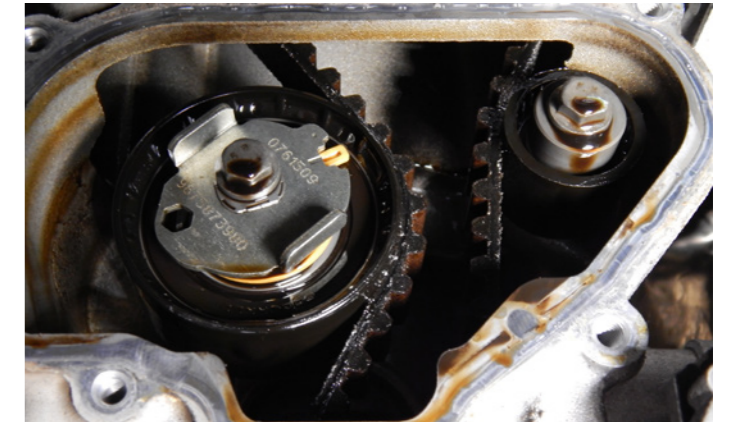
Figure 4

The vehicle was raised and the auxiliary drive belts were removed, along with the three retaining bolts for the crankshaft pulley and the timing belt cover. This revealed the timing belt tensioner and idler. (Fig.4)

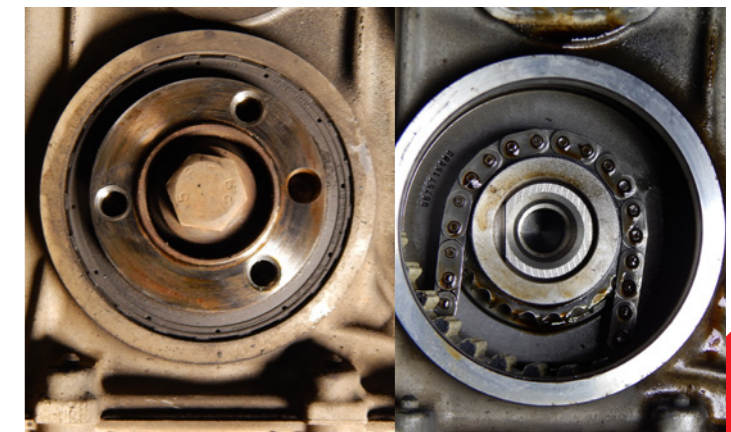
Figure 5

The crankshaft hub and oil seal were removed - revealing the end of the crankshaft and the oil pump sprocket and chain. (Fig.5)

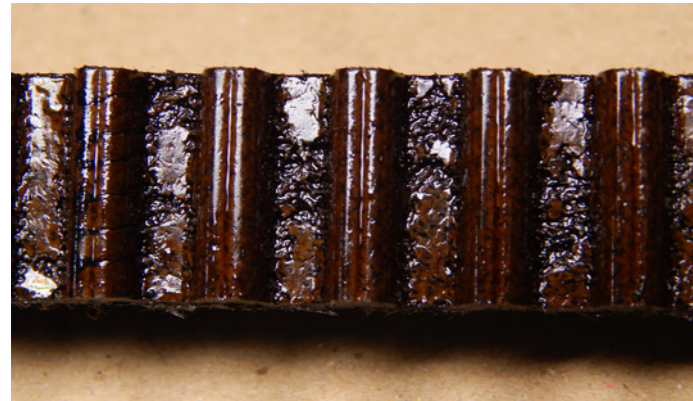
Figure 6

However, due to rapid degrading of the engine oil in vehicles used in an urban environment (because of low mileage/vehicles not reaching operating temperature), it is reported that there are numerous issues with the 3-cylinder, 1.2 PureTech engine - which uses a 'wet' timing belt and is fitted to many Peugeot and Citroen models. The timing belt material is subjected to wear and can deteriorate.

On inspection, there was no sign of thinning of the belt material. However, it was evident that the contact area with the drive pulleys had started to deteriorate, proving that this belt required replacement. (Fig.6)

With all the components removed, the engine could be reassembled using any new parts that were required. Firstly, the new timing belt was fitted from the top of the engine and attached to the camshaft pulleys. Then, with the vehicle raised, the camshaft hub was aligned with the crankshaft and installed with a new bolt - but not tightened. Next to be installed was the new timing belt tensioner and idler. With the belt carefully fitted to and around all the pulleys, the timing belt was tensioned by rotating the eccentric roller tensioner using a 15mm six-sided socket, until the marks aligned. Then, the tensioner and crankshaft bolts were tightened. (Fig.7)
