# Blue Print Top Tip

## Mitsubishi FTO - Crank Shaft Pulley

**Applications:** Mitsubishi FTO 2.0 (DE3A)

**Date Issued:** 05/2007

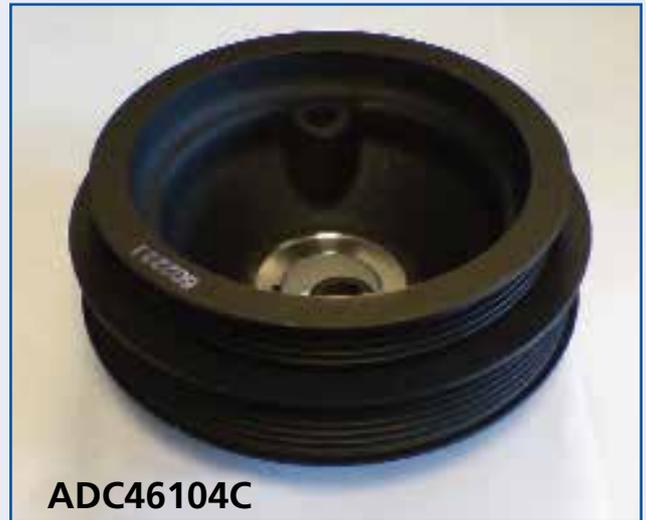
The Crankshaft pulley consists of two sections (Inner and outer), which are connected by a rubber damper.

This can in time slowly break up causing movement on the pulley.

If the Crankshaft pulley is operating with a worn rubber damper at high engine RPM, the pulley can oscillate and in extreme cases there is a possibility that the outer part of the pulley can come adrift.

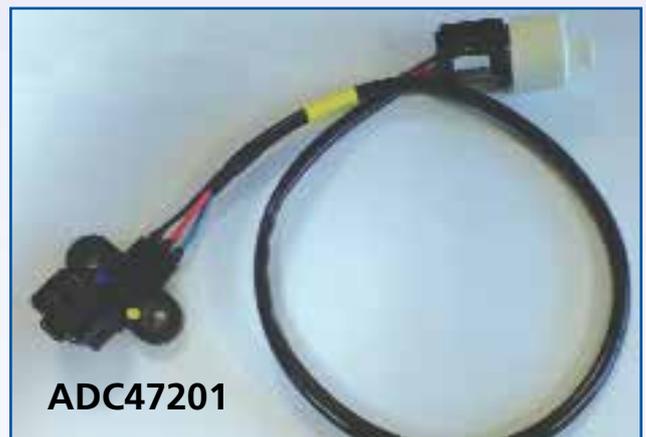
This excessive movement can cause the timing belt cover to move inwards and damage the Crank Angle Sensor Blade. If this part is damaged, the blade will act like a "knife" against the timing belt, with the potential of causing catastrophic engine failure.

**Linked part number: Crank Angle Sensor = ADC47201**
