febi 1000001

To fit: Hyundai Ioniq AE EV 2016-2019 88kw

Electrical Drive Motor Repair Kit

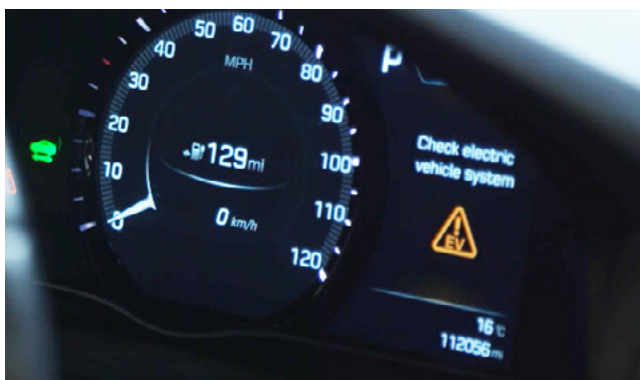
Figure 12

Check any system messages for the electrical vehicle, fault code P0C17 will be stored in the control unit. (Fig.12)

The vehicle requires to be driven at a speed of 20-50 kph until the resolver speed sensor has been calibrated. The fault message and code will automatically be erased if calibration has been successful.
