Toyota Echo, IST, Platz, Vitz 1, Will
Cypha and Yaris 1.

Axle Beam Mount

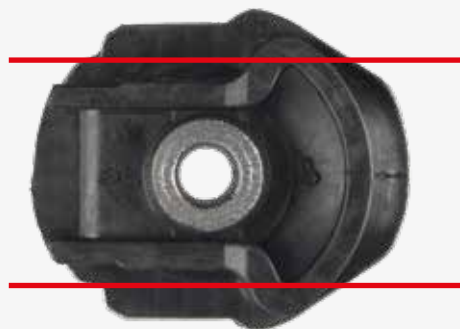
Figure 1

Uneven tyre wear and inconsistent vehicle handling.

The axle beam mounting rubber is worn and deteriorated, causing axle misalignment.

To remove the axle beam mounting, first mark the alignment of the bush to the axle. (Fig.1)
