febi 107793

Toyota Avensis, Corolla 2.0 D4d

Suction Control Valve

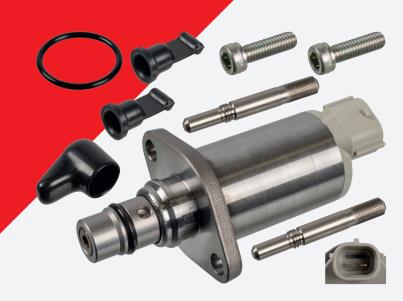
Engine surging, erratic idle and a sudden lack of power which can be intermittent. Engine fault codes logged relating to fuel rail pressure deviation.

The suction control valve (SCV) solenoid has extremely fine tolerances within its moving parts, which are quickly affected by dirt and or contaminated fuel.

A worn or contaminated SCV will cause the high-pressure fuel pump to deliver an inconsistent fuel pressure compared to what is being requested, by the engine control unit (ECU). Inconsistent fuel pressure at the injectors can cause surging as the ECU attempts to find the correct operating fuel pressure.

Check the fuel system for contamination, replace the fuel filter and suction control valve.

Remove the SCV, noting the connector position of the SCV to the pump, loosen bolts and remove. Then remove the large O-ring.

Install the new large O-ring to the fuel pump. Then, screw the two new guide pins into the mounting holes and apply engine oil on the small O-ring located on the SCV before fitting to the pump.

Install the SCV by carefully pushing it into the housing. When the SCV is in position, remove the guide pins, fit the new bolts, and tighten them according to the manufacturer's tightening torque.

Once the installation is complete, carry out the supply pump learning procedure and perform a high-pressure pump test using a suitable diagnostic tool to confirm that there are no leaks and that the fuel system is performing correctly.
