febi 182330

To Fit: Various models in the VAG range fitted with 1.8 & 2.0 TFSI engines.

Water Pump with Thermostat Housing

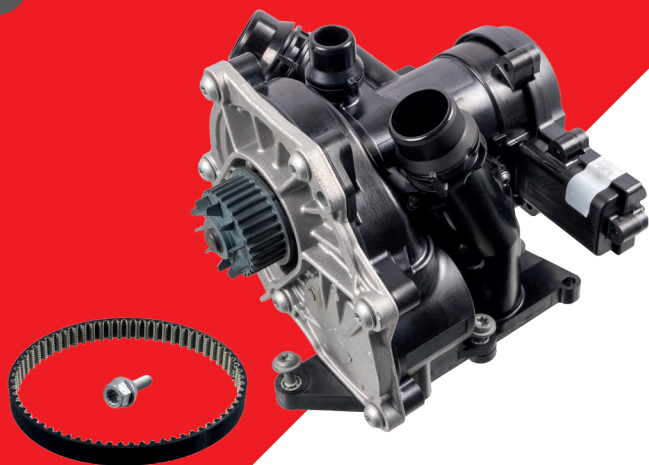
Intermittent overheating, temperature gauge displaying an incorrect reading, or a loss of coolant. This water pump/thermostat module is located underneath the inlet manifold. There may be traces of either fresh (damp) or old (crystallised) coolant showing on the front of the engine and hoses.

Hot and cold heat cycles can distort the sealing surfaces allowing coolant to leak from between the water pump and the thermostat module or from between the thermostat module and the engine block.

The internal rotary valves inside the thermostat module that alter the flow of coolant in the different cooling circuits can be restricted by a build-up of scale or sludge. This causes excessive strain on the drive motors which can lead to them overheating and failing.

Investigate the area at the front of the engine for leaks. Follow the manufacturer's instructions for removal making sure that the old gasket seals are not stuck to the engine block. Before refitting the new module, clean the gasket mating surfaces and surrounding areas thoroughly and renew the seals.

febi recommends that the coolant pipe between the thermostat and the oil cooler is also replaced (109682) as part of the repair.

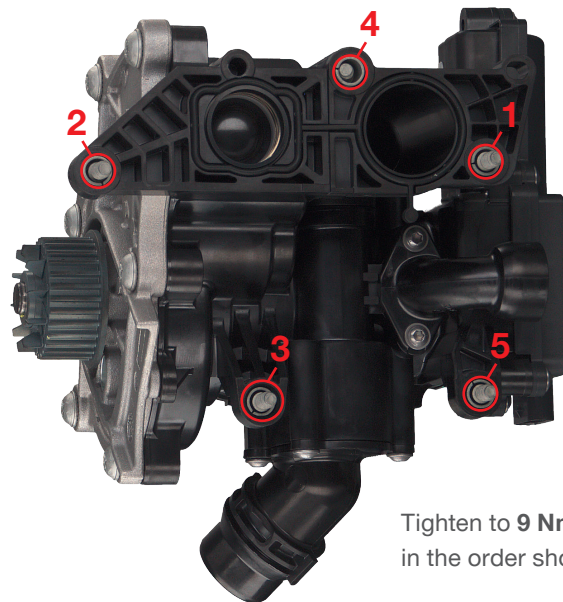
Tighten to **9 Nm**
in the order shown.
