# Blue Print ADM58089, ADM58096

To fit:  
Ford, Mazda and Volvo (various models)

## Control Arm Bush

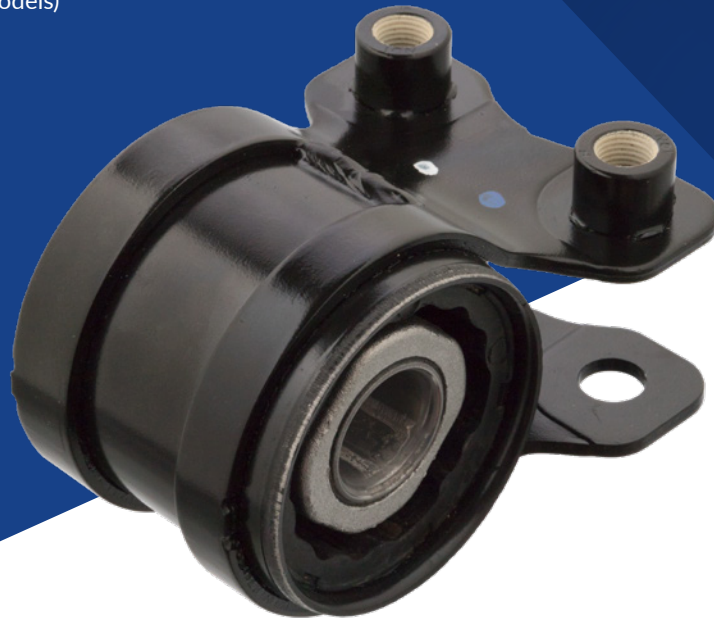
Uneven tyre wear and misalignment of the front suspension.

The lower suspension control arm bush is worn.

Blue Print provides an economical repair solution whereby the control arm bush can be replaced instead of the complete suspension control arm.

When replacing this bush it is important that the alignment of the original control arm bush is followed.

If the bush is not aligned correctly on the shaft of the suspension arm then there is a risk of premature failure and a shortened lifetime of the component.

**Note:** There is a special tool available from the vehicle manufacturer to assist in the replacement of the control arm bush. By using this tool it can be ensured that the installation position and press-fit depth of the bush will be correct.
