Blue Print

ADN11489, ADN11490,
ADN11491, ADN147225,
ADN147226, ADN17235

Nissan Navara D40 & Pathfinder R51
up to build date 15/09/2009

NISSAN NAVARA D40/PATHFINDER R51 – Four Wheel Drive Malfunction

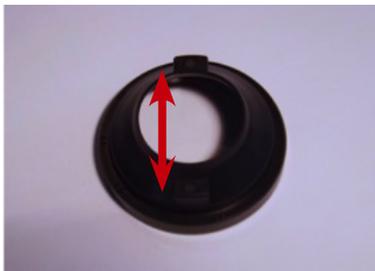
Original dust cover with
smaller drain-hole

Water ingress into the transfer box which gets past the rear prop-shaft dust cover and oil seal. This can affect one or more of the transfer box detect switches. There are three switches which perform multiple functions.

It is recommended that you drain the transfer box of oil, replace the rear prop-shaft oil seal (ADN17235) and fit a new modified dust cover and spacer (ADN17226 + ADN17225). The spacer should be installed inside the dust cover before fitting.

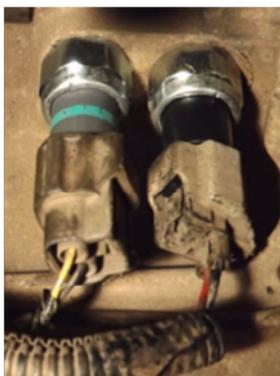
4wd low switch/
Automatic transmission
park switch

The other two switches are positioned together and further forward on the underside of the transfer box.

- **4wd Low Switch (Grey with green stripe) - ADN11489.**
- **Automatic Transmission Park (ATP) Switch (Black) - ADN11490.**

Although the diagnosis may only show one switch to be faulty, it is recommended that all three switches are replaced because of the increased risk of premature failure due to water ingress into the transfer box.

We recommend you replace the switches one at a time to prevent the risk of incorrect positioning/fitment.

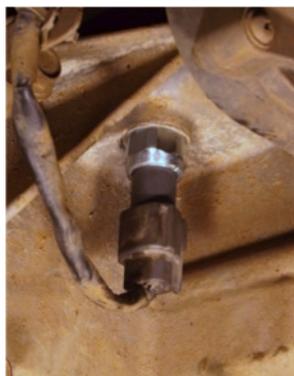
4wd shift switch

The three switches are located on the underside of the transfer box. The switch located towards the rear of the transfer box is:

- **4wd Shift Switch (Grey) - ADN11491.**
