# Blue Print ADT33693

To fit: Various Daihatsu, Scion, Subaru & Toyota models

## Concentric Slave Cylinder

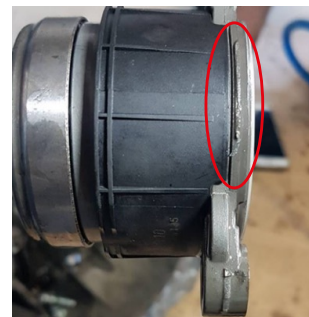
Fig. 1

During the bleeding process, fluid leaks from the concentric slave cylinder.

The leak is due to the incorrect positioning of the bearing in the transmission housing. If it is not in full contact with the transmission housing, hydraulic forces generated during clutch actuation can cause it to separate from the housing.

Example of damaged concentric slave cylinder with separated gasket. (Fig.1)

When installed, the concentric slave cylinder must be in full contact with its seat in the transmission housing.

Tighten all fixing bolts evenly by hand to allow for alignment, then tighten the bolts to the torque specified by the vehicle manufacturer.
