Blue Print ADM58067

to fit:
Mazda 6 Estate 2002>2008

Mazda 6 Estate - Luggage Cover Repair Kit

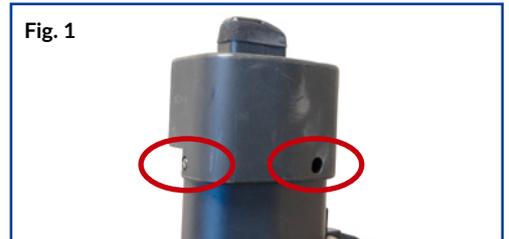
Fig. 1

- Firstly remove the LH (passenger side) plastic cover which is retained by two cross-head screws (Figure 1).
- Now lift the retractable cover from the housing. What you have is the leatherette cover bonded to a metal tube with a coiled spring hooked onto a plastic sleeve attached to a metal rod, running through the centre (Figure 2).

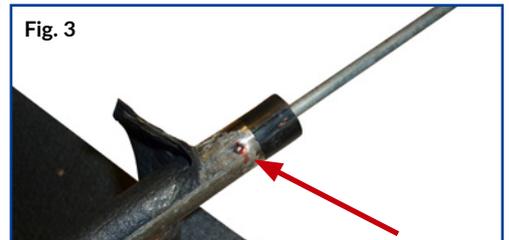
Fig. 3

- The plastic sleeve is located on the end that the metal rod protrudes. To enable the sleeve to be removed you must now carefully peel back some of the leatherette cover until the two indentations on the metal tube are visible. These indentations are crimping the sleeve in place (Figures 3).
