## febi 172376

To fit: Various Volkswagen, Audi, SEAT and Škoda models equipped with a direct shift transmission

## Thermostat for transmission oil cooler with seal rings

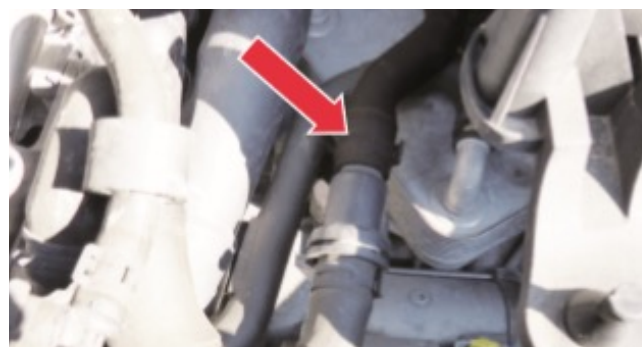
Fig 1: The thermostat is integrated into the flexible hose at the heat exchanger (under the air filter housing).

Use a suitable diagnostic tool to check the temperature data of the engine and transmission. Replace the faulty transmission oil cooler thermostat, ensuring the directional arrow on the new part is aligned in the correct direction. Bleed the cooling system of any air, road test the vehicle, then recheck coolant temperature data to ensure correct operation.

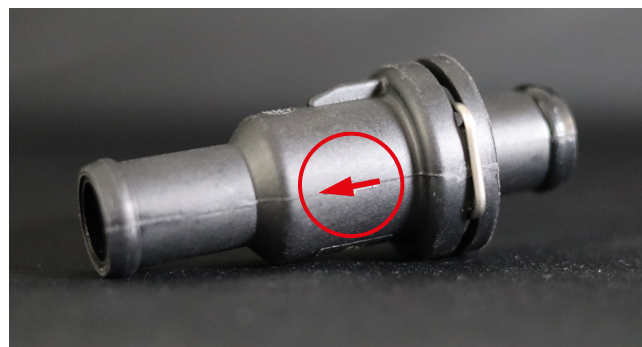
Fig 2: Important when replacing the thermostat: note the installation direction (arrow).
