# Ford Mondeo Rear Suspension

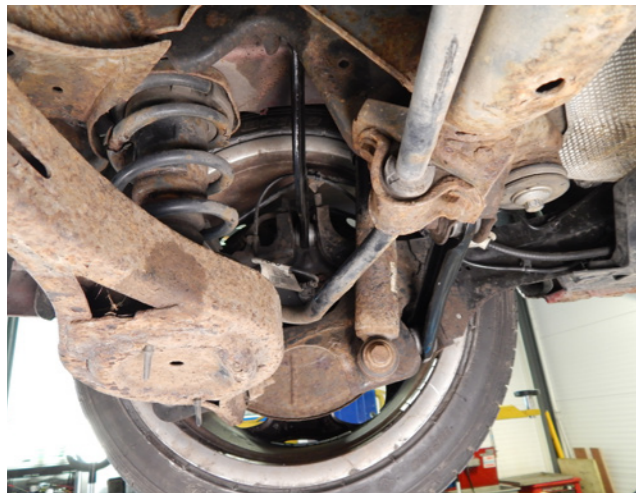
Fig. 1

This Mondeo was equipped with an independent multilink rear suspension system which was available in standard, sports and heavy duty versions - with or without self-levelling dampers or electronic control. However, all other suspension parts were fundamentally the same. This was all subject to each model specification. (Fig 1)

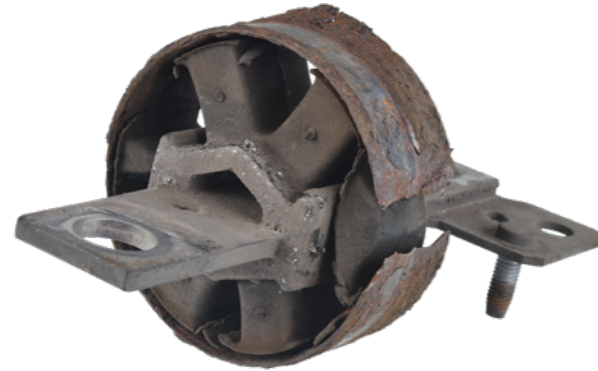
Fig. 2

The rear trailing arm bushes are a common component of this system and can deteriorate over time. The rubber becomes torn and the outer casing corrodes, giving the vehicle a 'slumped' look; causing the suspension to become out of alignment and operate incorrectly. (Fig 2)

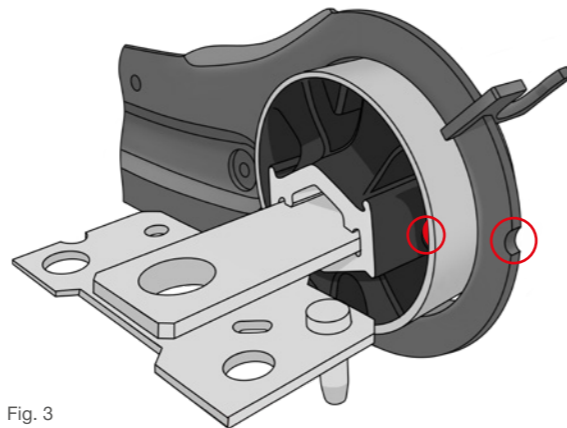
Fig. 3

These bushes can be replaced separately, which saves replacing the whole trailing arm. This can be executed by using a special tool to push the old bush from the arm and pull the new one in; not forgetting firstly to align the bush - with the alignment points on the bush - with the arm. (Fig 3) This is imperative for the correct operation of the bushes.

The new febi bushes' outer metal casing has a leading edge for ease of fitment. Being made from vulcanised natural rubber gives it excellent mechanical properties and hardness - ensuring a long service life.
