NEW PRODUCT HIGHLIGHT | JUL2019

febi 105765

to fit:
Mercedes Benz C class C203 model 2000 >

Steering Column Switch assembly

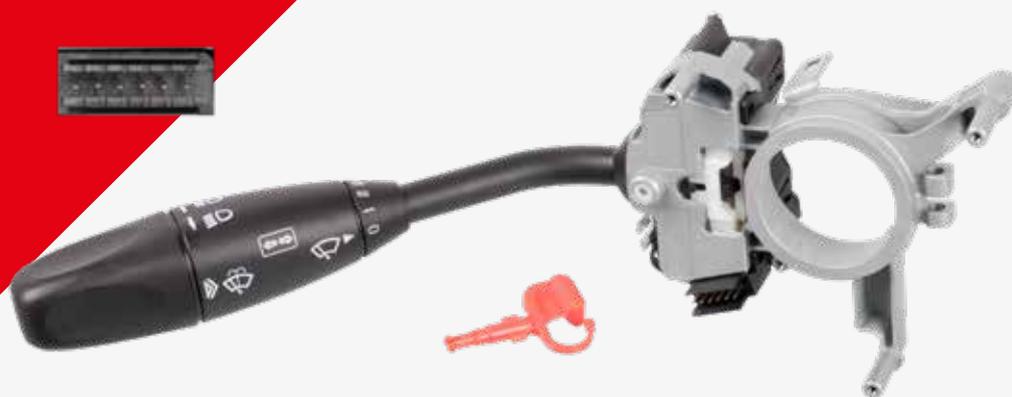
Multifunction column switch, to control the directional indicator, lights and windscreen wipers.

The multifunction switch loses functionality; the cause of this issue, is that the wiring which goes into the stalk/lever breaks due to continuous movement and use, causing an open circuit.
