# NEW PRODUCT HIGHLIGHT | JUL2022

# Blue Print ADBP610059

various Citroën, DS, Ford, Mazda, Peugeot and Toyota models fitted with the 1.4, 1.5 & 1.6 turbo-diesel engine

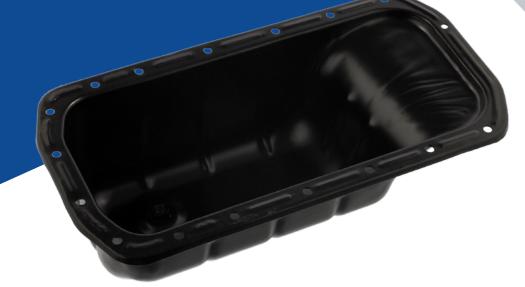
# Oil pan with oil drain plug and seal ring

The oil pan covers the bottom of the engine block and serves as a reservoir for the engine oil, before re-entering the engine's lubrication circuit via the oil pump pick-up tube.

The oil pan is made from quality cold-rolled steel, using the stamping process.

Because the engine oil pan is located at the lowest part of the engine, it can be exposed to various 'knocks' and 'scrapes' in every day driving. It is not unusual for the oil pan to make contact with traffic-calming speed bumps. If these are hit at speed, the oil pan can be dented or 'creased', which causes the paint to crack and allows moisture and road debris to attack the unprotected steel. After a period of time, the metal corrodes, resulting in a fine film of oil forming around the underside of the vehicle - as the leak increases, oil droplets will form and leave a stain on the ground underneath the vehicle.

The oil leak should be repaired as soon as it is noticed, by replacing the oil pan. It is also recommended that the engine oil and filter is replaced at the same time.
