Toyota Estima (Lucida/Emina) 2.2DT 1992 > 1999

Flexible Coupling Kit for Propshaft

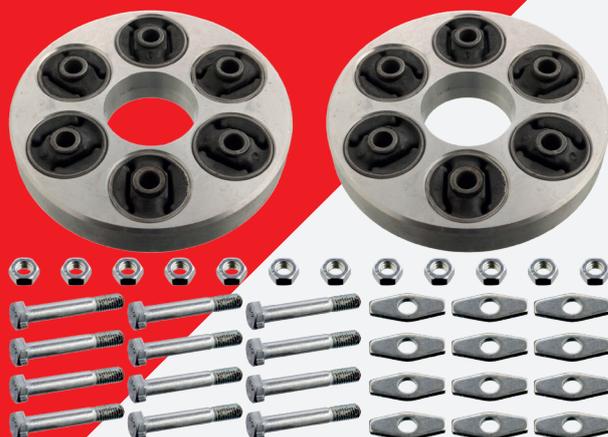
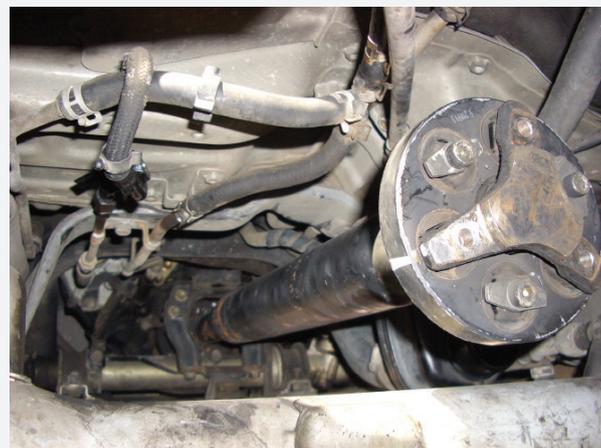
Figure 1

The alternator, air conditioning compressor, power steering pump and cooling fan are located forward of the mid-mounted engine and are driven by the ancillary driveshaft. If the condition of the flexible couplings deteriorates, it will lead to separation of the rubber from the metal carrier – causing rapid wear in the joints.

A worn coupling is normally associated with excessive noise and vibration at idle and should be repaired by replacing the coupling at each end of the ancillary shaft.

- Mark the shaft flanges prior to removal and refit them in the same position (this is to keep the correct shaft balance).
- If possible, do not remove the 'Horse Shoe' shaped carrier assembly (fig 1) as this may obscure access to the front coupling retaining bolts. The bolts should be accessible using an extension bar and socket, whilst rotating the driveshaft to access one bolt at a time. However, if removal is necessary, it is important to mark the original position beforehand as the Horse Shoe carrier position is factory set for optimum alignment.
- Remove any corrosion from the driveshaft flanges (especially the engine coupling) before refitting.
