# febi 109034

Ford Focus, Mondeo, C-Max, S-Max 1.6,  
1.8, 2.0, 2.2 Diesel Engines

## Injector nozzle for particle filter regeneration

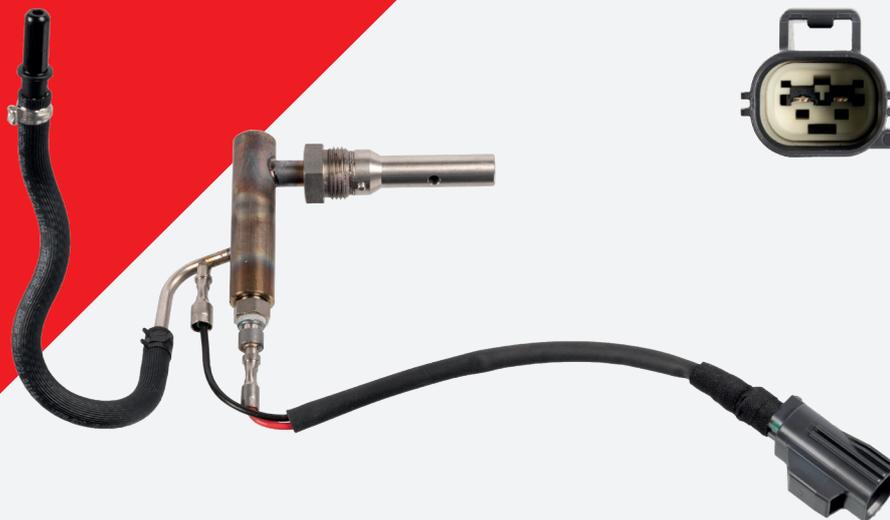
Poor engine performance and engine malfunction lamp illuminated, due to the diesel particulate filter being blocked and failing to carry out regeneration.

The Injector nozzle is physically blocked, or there is a blown fuse due to an internal short circuit caused by the injector nozzle glow plug overheating, or fuel supply pump failure.

Diagnose possible faulty exhaust injector nozzle, by connecting a hand held vacuum pump to the fuel line that supplies the nozzle, check if it holds a vacuum. If a vacuum is held, the injector is blocked and will need replacing.

If the fuse for the injector heater glow plug or pump has blown, then test the glow plug resistance. Nominal 1.1 Ohms, if it is less than 0.8 Ohms or greater than 1.3 Ohms then the injector glow plug is faulty, which is part of the injector unit.

If all values for the injector nozzle are within specification, check the condition of the fuel line supplying the injector and fuel supply. Then run the pump, if the pump is noisy, or does not run, check the wiring to the pump and make sure the fuel lines are not blocked. Replace any faulty parts as necessary.

After the repair has been carried out, a particulate filter service regeneration will need to be carried out in a well ventilated area.
